ADFREEZE BOND STRESS REDUCTION

Utilizing SlickCoat™ Friction Reduction Epoxy Coating

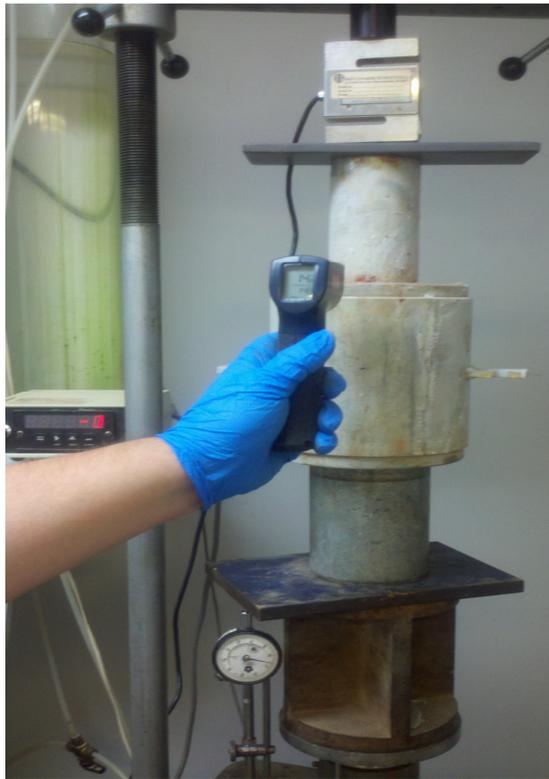
Photo_1

The laboratory testing included determining adfreeze bond stresses under displacements up to 0.170 inches for 2.9 inch outside diameter steel pipes embedded in 6 inch diameter cylindrical sections of frozen soil. The samples were tested by advancing the steel pipes through the soil samples using steel retainer rings with a 3.0 inch hole at the base of the samples to allow the samples to stay intact as the pipes were advanced. The rate of advancement was 0.045 inches per minute. Load versus deflection readings were obtained at intervals of 0.01 inch. The loads at the deflection intervals were determined by a digital load cell.
